**Historical And Architectural Study
Of Buildings And Artifacts
Associated With The Bulltown Historic Area,
Burnsville Lake Project,
Braxton County, West Virginia**

September 1979

**U. S. Army Corps Of Engineers
Huntington District**

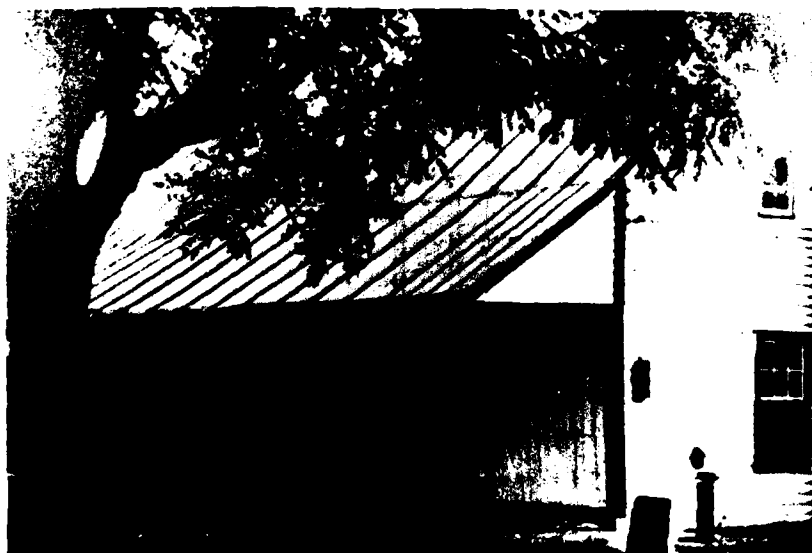
Figure 25. Hubert and Harley Fleming dwelling, facade and right end, ca. 1975. Note double hung sash window and porch roof details.

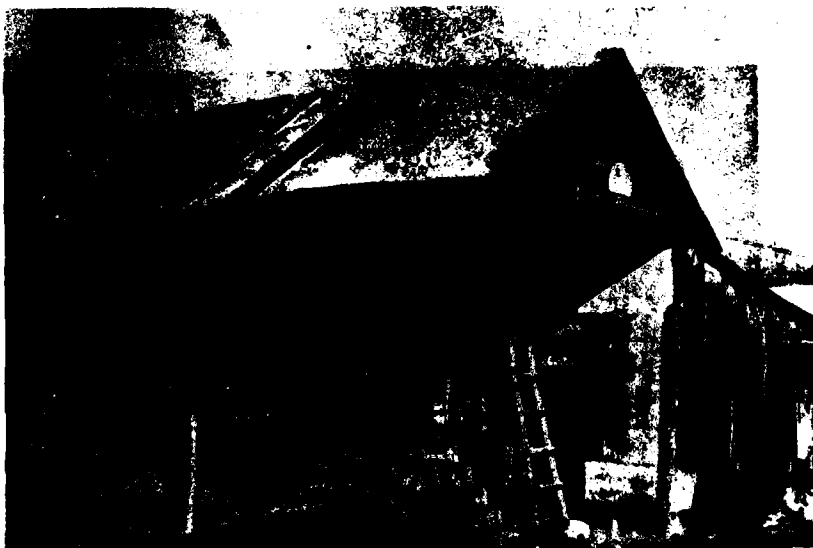
Figure 70. Cunningham outbuilding. Granary, facade, and left side. Note spaced, diagonal planking at left to provide air circulation into the corncrib.
